Sempatap Thermal on 8 Domestic Properties for Wolverhampton City Council

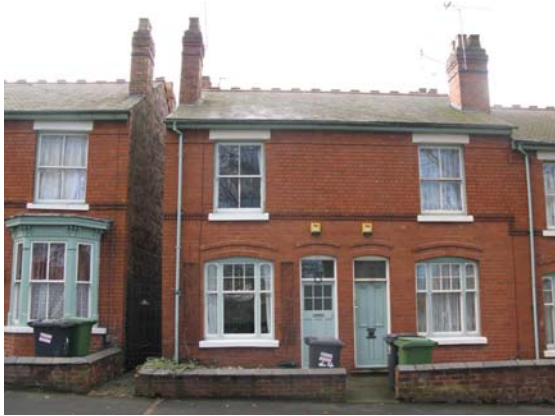
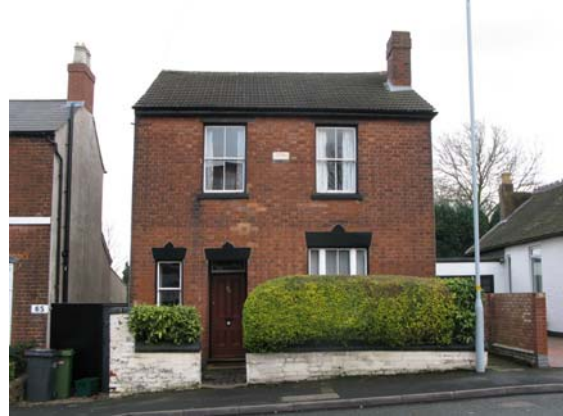
Visual image

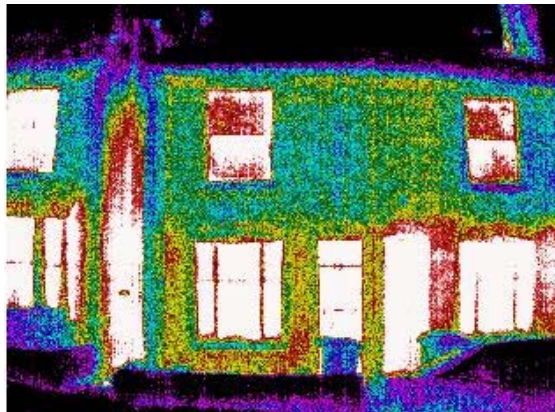
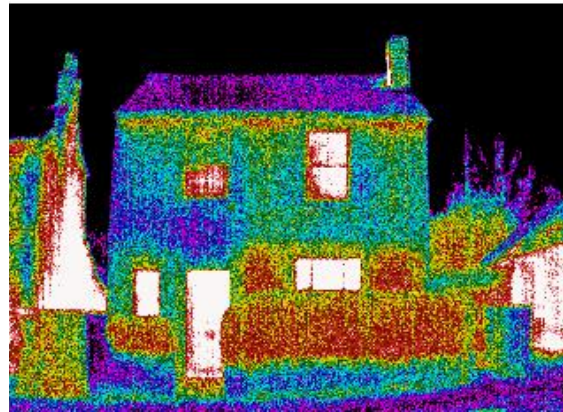
Before thermal

In the before image, inconsistent temperatures can be seen in red and yellow colours indicating heat loss due to poor detailing or missing/ damaged insulation. Warmer temperatures are seen on the bottom level of this property suggesting heating is on compared to the above level; however it could simply be there is no insulation at all. Analysis of the property after insulation reveals significantly reduced heat loss across the elevation suggesting a much more energy efficient property.

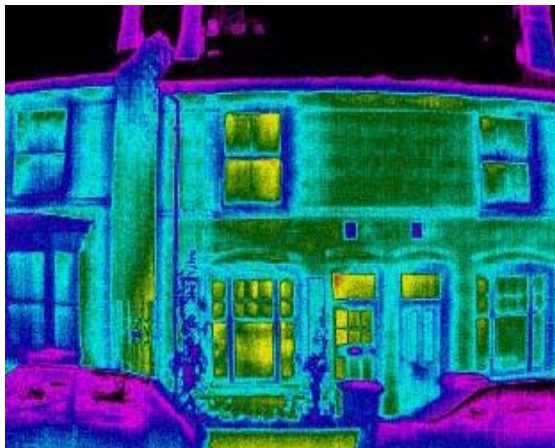
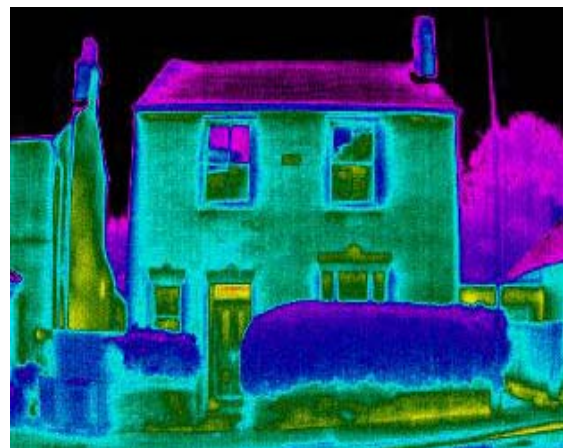
After thermal
